Vibration Assessment Capability

1. High Vibration on Produced Water System

2. High Vibration of Filter Backwash Line

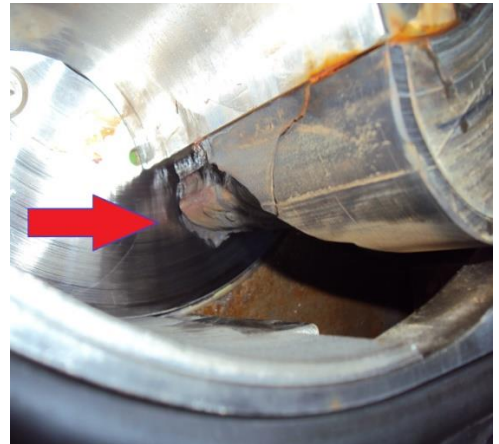
A produced water system using lobe pumps experienced high levels of piping vibration that resulted in the fatigue failure of two small bore instrument connections and damage to lobe pumps.

Vibration data was gathered by the inspection team and provided to SRJ. Following an assessment of the vibration data and with the support of an acoustic simulation model, the root cause was identified as the inappropriate locating of pulsation dampers, which was resulting in cavitation at the inlet to the lobe pumps

Figure 2: Damaged lobe on pump

The acoustic simulation was used to determine the optimum locations for the pulsation dampers. The dampers were relocated as proposed and verification vibration survey results showed a ten-fold reduction in vibration levels, and no repeat damage occurred to the repaired lobe pumps.

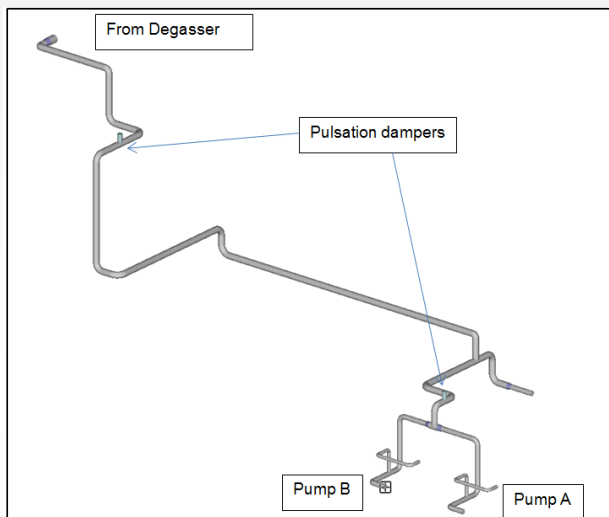
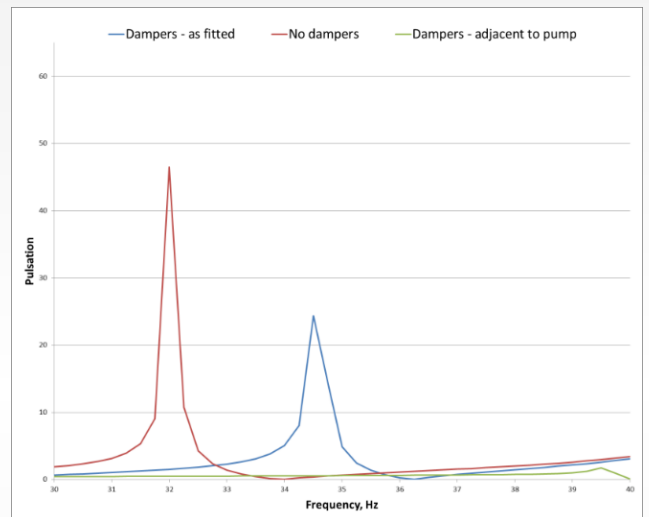
Figure 3: Acoustic model and predicted pressure pulsations

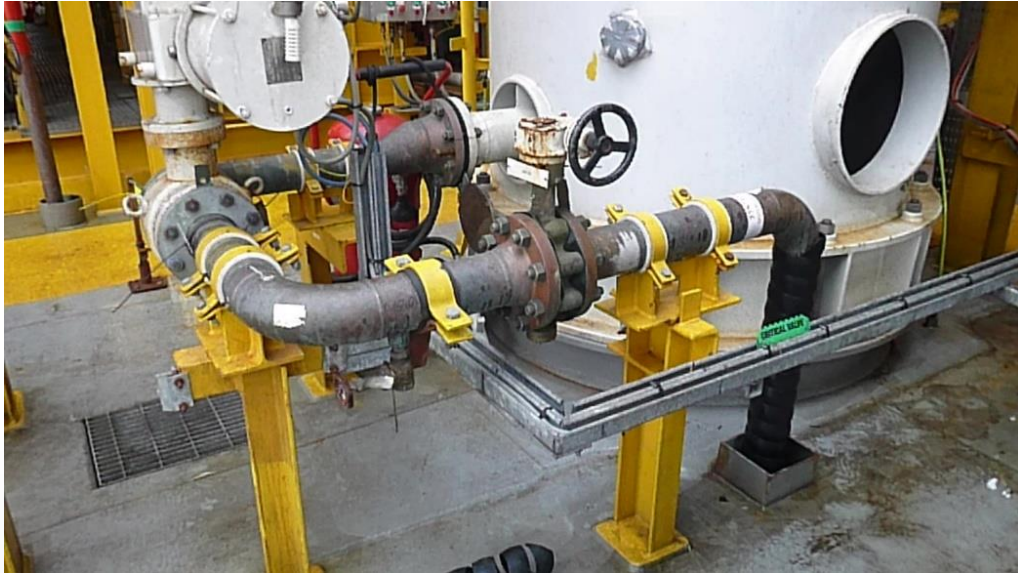
Figure 4: Backwash piping

A review of the video identified two separate problems:

- Continuous vibration during backwash
- A transient event resulting in significant pipework deflections as the end of the backwash cycle

The root causes were determined to be cavitation due to the pressure drop across a single restriction orifice resulting in the continuous vibration during backwash. The transient event occurred when the control valve closed, the cause was identified as the formation of a partial vacuum resulting in a vapour cavity, on collapse of the cavity a significant transient forces were generated resulting in the observed piping deflections.

The proposed remedial modifications were:

- Two restriction orifice plates were installed in series to stagger the pressure drop, minimising the cavitation
- The installation of a vacuum breaker/air release valve downstream of the control valve prevented the partial vacuum conditions being generated on control valve closure

Following their implementation, no further vibration concerns were evident on the backwash line.
