CASE STUDY

Enclosure Repair

CHEMICAL & FERTILISER PRODUCTION

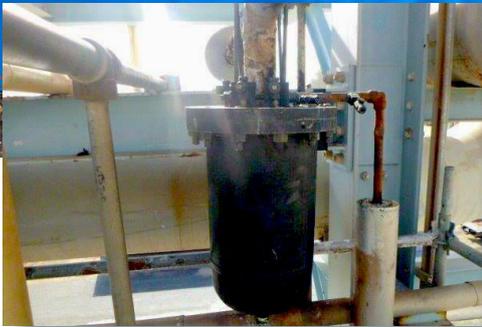
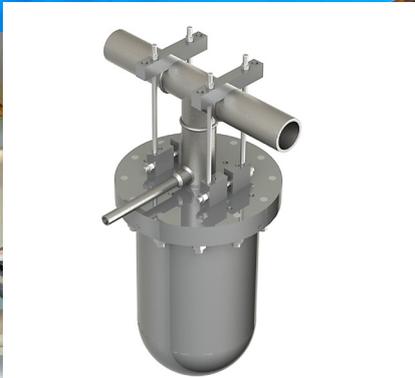
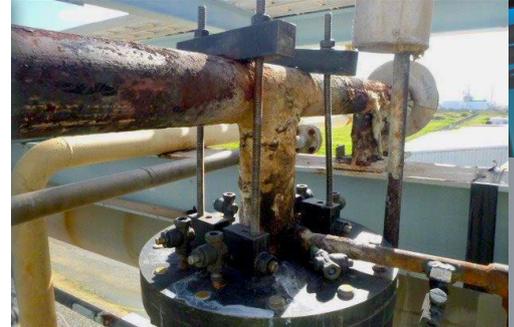
Medium pressure steam at 380°C and 4000kPa was leaking from an existing leak sealing enclosure that had been installed on a failed section of pipework. Radiographs revealed that the pipework had completely separated inside the currently installed repair.

SRJ delivered a bespoke repair solution that accommodated the complicated geometry and site restrictions. A unique 'top hat' arrangement was used to fully enclose the failed clamp and the drain valve.

The enclosure incorporated peripheral seals in a two part upper endcap that sealed against the 3" pipe. The 'top hat' section was then drawn up over the failed arrangement and sealed against the upper endcap.

The enclosure was securely held in place by a pair of strongback beam supports situated on the top of the horizontal pipework above.
