## CASE STUDY

# Bespoke Valve Repair

## MAJOR OIL REFINERY

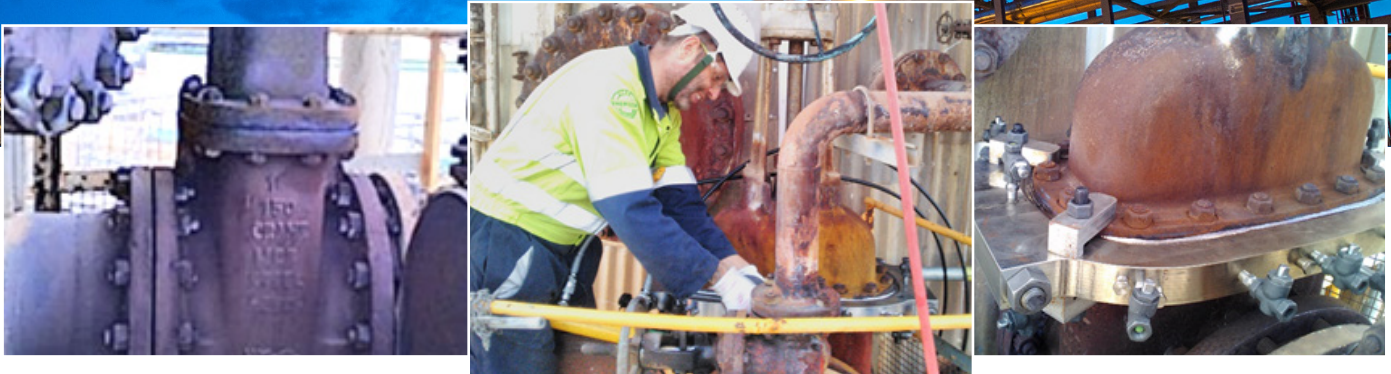
A diesel oil leak at 310 degC occurred on the 16" oval bonnet valve posing a threat to refinery operation and personnel safety.

SRJ delivered a custom enclosure repair by accurately matching the complex profile with CNC machining using a SolidWorks CAD model.

The bespoke enclosure incorporated peripheral seals that fitted against the flange surface and a sealing compound was injected through valves installed into drilled ports. To complete the installation, finger clamps were used to position the enclosure.

The solution delivered a safe and secure repair to the bonnet valve flange.
